# Coastal Crash Consultants

Experts in Traffic Crash Investigation and Reconstruction

## Event Data Recorder “Black Box” Information

**We can recover crucial crash data from a vehicle that has been in a crash. This data, which is stored in the vehicle's event data recorder, can be used to assist you in making informed decisions on insurance claims .**

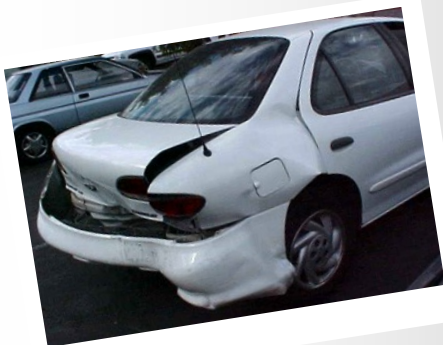
The insured filed a police report stating that their vehicle had been struck in the rear and damaged while parked. They had purchased the vehicle four days prior to the claim, before the pre-inspection had been completed.

The insured signed a "Release to Image Data" allowing data to be retrieved. As shown by the chart above, the vehicle was braking and had slowed from 30 MPH to 12 MPH just prior to the collision. Due to this information, it was determined that the vehicle was not stopped at the time of the collision but rather it was slowing. This information would not have been available without downloading it from the EDR.

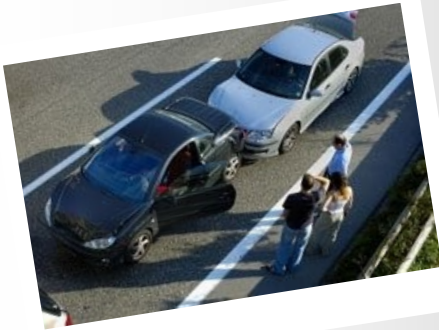
The claimant, in Vehicle 1, stated that they had stopped on an expressway due to traffic stopped ahead. They said that at that point, they were rear-ended by the insured in Vehicle 2. The insured claimed that they were also struck from behind and forced into Vehicle 1. The insured vehicle was equipped with an EDR, which captured two events critical to the case.

The first event indicated a positive Delta-V, or a gain in momentum. The only way a vehicle can gain momentum or increase in MPH in a crash is to be struck from behind. The second event showed a negative Delta-V, or a reduction in momentum. This was due to the insured striking the claimant's vehicle in the rear, causing the insured's vehicle to have a reduction in momentum or MPH. Furthermore, the time between the increase and subsequent decrease in momentum established that the insured's vehicle was at least 10 feet behind the claimant's vehicle when it was struck in the rear by the third vehicle, which then pushed it into the claimant's vehicle.

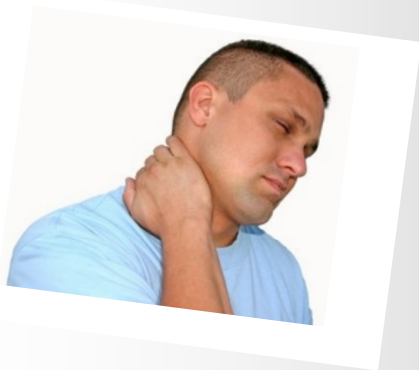
The claimant alleged that he was a passenger in vehicle that was struck by the insured, and that he suffered neck and back injuries from the accident. It was a minor crash and no passengers were listed on the police report.

The claimant signed a "Release to Image Data" allowing data to be retrieved from their vehicle. Upon examination of the EDR data, it was revealed that the passenger seat was unoccupied at the time of the crash. This type of information is only available through the downloading of EDR data. Seat occupancy is a standard because it is used by the airbag module to determine if the airbag should be deployed. In addition, it can identify the size of the occupant because it also uses this information to determine the strength required to deploy the airbags. When the insured was asked to give an Examination Under Oath, he never responded.
